**Flood Control Project Maintenance  
Levee Inspections**

## Maintenance Issue Types Only, Levee Inspection Report By Mile - Spring 2018

### Reclamation District No. 2063 Crows Landing

Waterway	Bank	Unit Miles	Inspection Start/End	Inspector
Unit No. 01 San Joaquin River	Right	10.44	03/27/2018 03/27/2018	Richard Willoughby

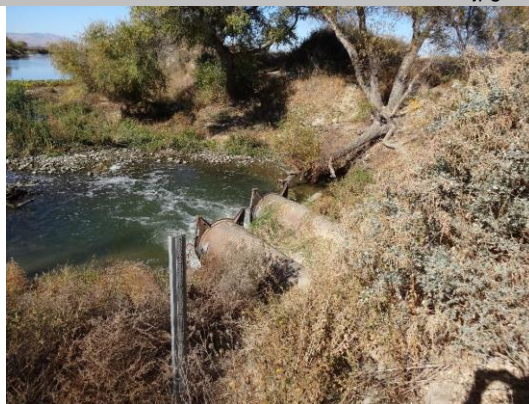
Photo 1 of 3 : UCIP\_SP\_2018\_50218\_43204.jpg

FS\_ID:50218  
DS\_ID:22076  
EP\_NO: N/A  
Repair Type: No Action Needed  
Crossing Status: Found  
UCIP Comments: 08/23/2016: WS flapgates were held open by a piece of wood. Pipes may be used temporarily for irrigation. (K. Fazel - UCIP)11/05/2013: working during the inspection. (P. Amatya - DWR)  
FIELD\_STRUCT\_DESC: [Lateral Drain No. 5] 1 of 2: 48-inch corrugated metal gravity drainage pipe through the levee, 25.5 feet below the crown. Slide gate in a corrugated metal pipe (CMP) riser on the waterside (WS) slope. Flap gate on the WS end. 70-foot-long cobble spillway to river. Installed by USACE in 1961. [Additional Reference(s): DWR Levee Log, 1992. USACE San Joaquin O&M Manual 6, September 1961, (HLM 1.35)].  
FS Date: 11/5/2013

WS view: two outfall CMP pipes on levee slope.

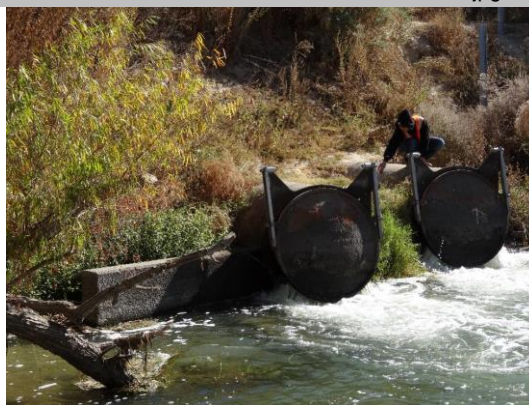
Photo 2 of 3 : UCIP\_SP\_2018\_50218\_43203.jpg

WS view: two outfall CMP pipes with flap gates on concrete headwall.

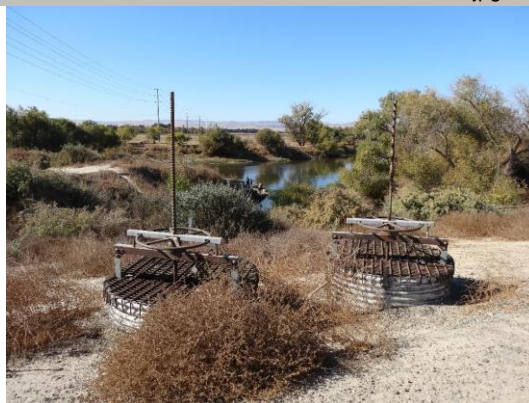
Photo 3 of 3 : UCIP\_SP\_2018\_50218\_43202.jpg

Comment Code					
Inspector Comment					
FS_ID:50218 DS_ID:22076 EP_NO: N/A Repair Type: No Action Needed Crossing Status: Found UCIP Comments: 08/23/2016: WS flapgates were held open by a piece of wood. Pipes may be used temporarily for irrigation. (K. Fazel - UCIP)11/05/2013: working during the inspection. (P. Amatya - DWR) FIELD_STRUCT_DESC: [Lateral Drain No. 5] 1 of 2: 48-inch corrugated metal gravity drainage pipe through the levee, 25.5 feet below the crown. Slide gate in a corrugated metal pipe (CMP) riser on the waterside (WS) slope. Flap gate on the WS end. 70-foot-long cobble spillway to river. Installed by USACE in 1961. [Additional Reference(s): DWR Levee Log, 1992. USACE San Joaquin O&M Manual 6, September 1961, (HLM 1.35)]. FS Date: 11/5/2013

WS view: two slide gates in CMP risers on levee slope.

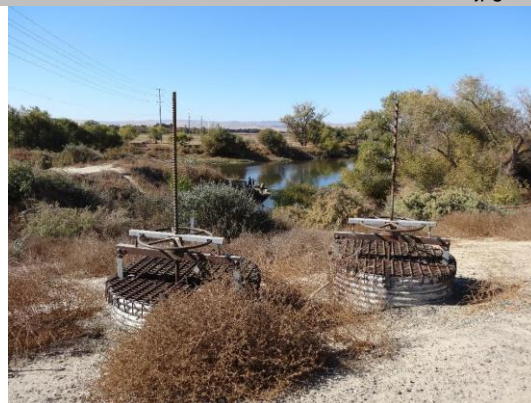
Photo 1 of 3 : UCIP\_SP\_2018\_50217\_43217.jpg

FS\_ID:50217  
DS\_ID:22119  
EP\_NO: N/A  
Repair Type: No Action Needed  
Crossing Status: Found  
UCIP Comments: 08/23/2016: WS flapgates were held open by a piece of wood. Pipes may be used temporarily for irrigation. (K. Fazel - UCIP)11/05/2013: working during field inspection. (P. Amatya - DWR)  
FIELD\_STRUCT\_DESC: [Lateral Drain No. 5] 2 of 2: 48-inch corrugated metal gravity drainage pipe through the levee, 25.5 feet below the crown. Slide gate in a corrugated metal pipe (CMP) riser on the waterside (WS) slope. Flap gate on the WS end. 70-foot-long cobble spillway to river. Installed by USACE in 1961. [Additional Reference(s): DWR Levee Log, 1992. USACE San Joaquin O&M Manual 6, September 1961, (HLM 1.35)].  
FS Date: 11/5/2013

WS view: two CMP risers with slide gates on levee slope.

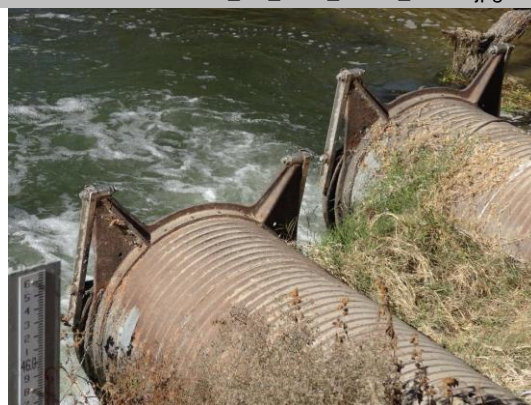
Photo 2 of 3 : UCIP\_SP\_2018\_50217\_43216.jpg

WS view: two CMP outfall pipes with flap gates on levee slope.

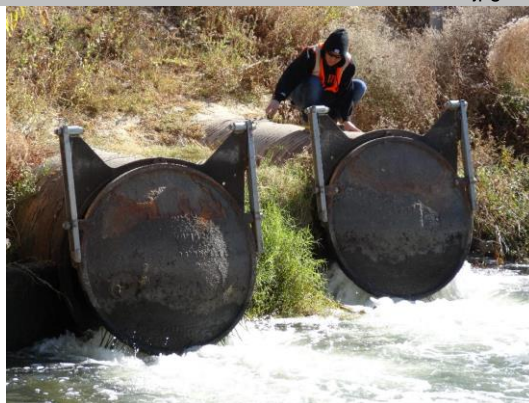
Photo 3 of 3 : UCIP\_SP\_2018\_50217\_43215.jpg

Comment Code						
Inspector Comment						
FS_ID:50217						
DS_ID:22119						
EP_NO: N/A						
Repair Type: No Action Needed						
Crossing Status: Found						
UCIP Comments: 08/23/2016: WS flapgates were held open by a piece of wood. Pipes may be used temporarily for irrigation. (K. Fazel - UCIP)11/05/2013: working during field inspection. (P. Amatya - DWR)						
FIELD_STRUCT_DESC: [Lateral Drain No. 5] 2 of 2: 48-inch corrugated metal gravity drainage pipe through the levee, 25.5 feet below the crown. Slide gate in a corrugated metal pipe (CMP) riser on the waterside (WS) slope. Flap gate on the WS end. 70-foot-long cobble spillway to river. Installed by USACE in 1961. [Additional Reference(s): DWR Levee Log, 1992. USACE San Joaquin O&M Manual 6, September 1961, (HLM 1.35)].						
FS Date: 11/5/2013

WS view: front view of two CMP outfall pipes with flap gates on levee slope.

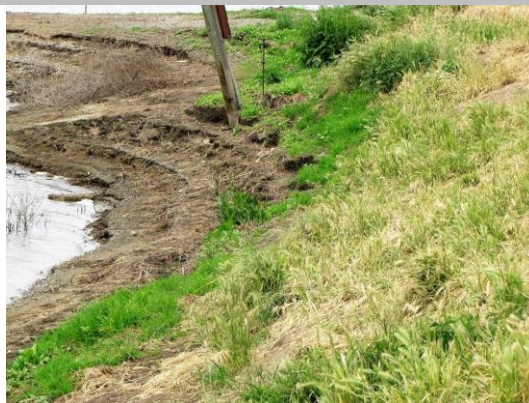
Photo 1 of 4 : SP\_2018\_RD2063\_112\_59\_20180307\_00011.jpg

LM Start	1.83	Rating **	A/W	Issue No.	59
LM End	1.93	Issue Type +	Ma	Location *	WS
Category	Earthen Levee			GPS Latitude/Longitude	
				Start	End
Item	Erosion / Bank Caving			37.457653 °	37.456258 °
				-121.033728 °	-121.033645 °
DWR ID	DWR_RD2063_01_s_2017_59				
Comment Code					
E1 : Note and monitor erosion site.					
Inspector Comment					
Minor erosion at waterward slope was repaired.

Looking downstream at minor erosion on waterward slope.

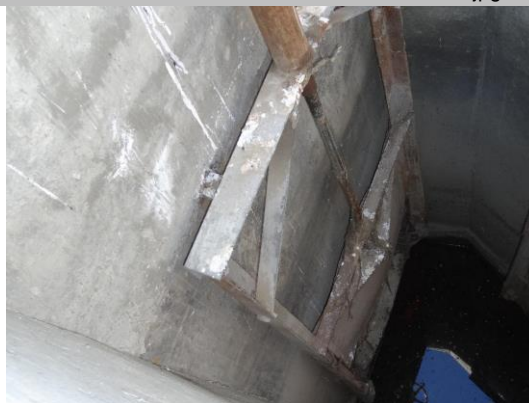
Photo 3 of 3 : UCIP\_SP\_2018\_51823\_43346.jpg

Comment Code						
Inspector Comment						
FS_ID:51823						
DS_ID:22081						
EP_NO: N/A						
Repair Type: No Action Needed						
Crossing Status: Found						
UCIP Comments: - concrete standpipe on waterside toe.- concrete distribution box on landside.- an alfalfa valve on waterside toe.						
FIELD_STRUCT_DESC: 30-inch corrugated metal gravity drainage pipe through the levee, 12 feet below the crown. Flap gate on the waterside (WS) end. Slide gate in a concrete distribution box on the landside (LS) end. Concrete U-shaped headwall on the WS end. [Additional Reference(s): DWR Levee Log, 1992. USACE San Joaquin O&M Manual 6, September 1961, (HLM 2.29)].						
FS Date: 11/5/2013

LS view: slide gate in concrete distribution box.

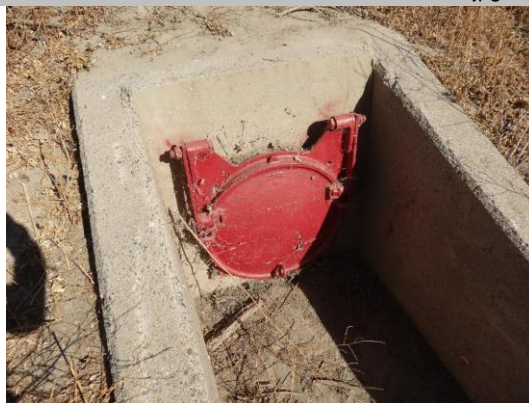
Photo 2 of 3 : UCIP\_SP\_2018\_24469\_43644.jpg

LM Start	3.29	Rating **	M	Issue No.	70 (cont)	
LM End	3.29	Issue Type +	Ma	Location *		
Category	Supplemental			GPS Latitude/Longitude		
				Start	End	
Item	DWR UCIP LMA Responsibility			37.441213 °	37.441213 °	
				-121.021130 °	-121.021130 °	
DWR ID						
Comment Code						
Inspector Comment						
FS_ID:24469						
DS_ID:22089						
EP_NO: N/A						
Repair Type: Non-Urgent						
Crossing Status: Found						
UCIP Comments: - cleaning required in inlet pipe.- new flap gate						
FIELD_STRUCT_DESC: *ABANDONED* 24-inch corrugated metal						
gravity drainage pipe through the levee, 12.5 feet below the crown. Flap						
gate on the waterside (WS) end. Concrete headwall on each end.						
[Additional Reference(s): DWR Levee Log, 1992. USACE San Joaquin						
O&M Manual 6, September 1961, (HLM 3.33)].						
FS Date: 11/5/2013

WS view: new flap gate, and U typed concrete headwall.

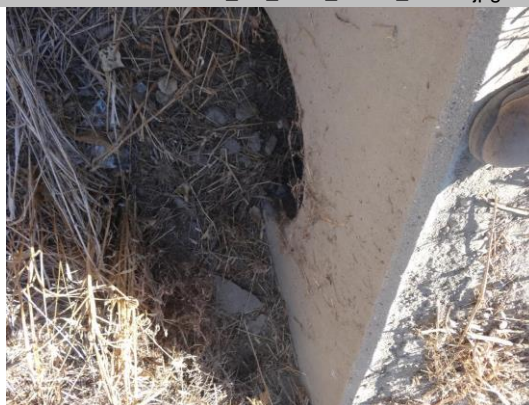
Photo 3 of 3 : UCIP\_SP\_2018\_24469\_43643.jpg

LS view: CM pipe and concrete headwall on levee slope. Debris blocking inlet pipe.

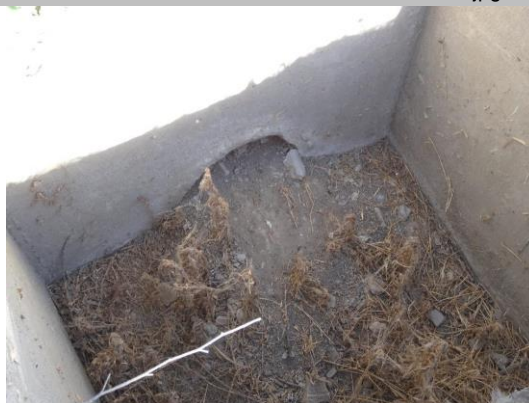
Photo 3 of 3 : UCIP\_SP\_2018\_24485\_43665.jpg

LM Start	3.64	Rating **	M	Issue No.	71 (cont)	
LM End	3.64	Issue Type +	Ma	Location *		
Category	Supplemental			GPS Latitude/Longitude		
				Start		End
Item	DWR UCIP LMA Responsibility			37.436845 °	37.436845 °	
				-121.017826 °	-121.017826 °	
DWR ID						
Comment Code						
Inspector Comment						
FS_ID:24485						
DS_ID:22093						
EP_NO: N/A						
Repair Type: Non-Urgent						
Crossing Status: Found						
UCIP Comments: - new flap gate on waterside.- cleaning and clearing of inlet box needed.						
FIELD_STRUCT_DESC: 24-inch corrugated metal gravity drainage pipe through the levee, 12 feet below the crown. Flap gate and concrete saddle on the waterside (WS) end. Concrete drop inlet box on the landside (LS) end. Installed by USACE in 1961. [Additional Reference(s): DWR Levee Log, 1992. USACE San Joaquin O&M Manual 6, September 1961, (HLM 3.69)].						
FS Date: 11/5/2013

LS view: inside view of inlet box on levee toe. Debris blocking inlet pipe.

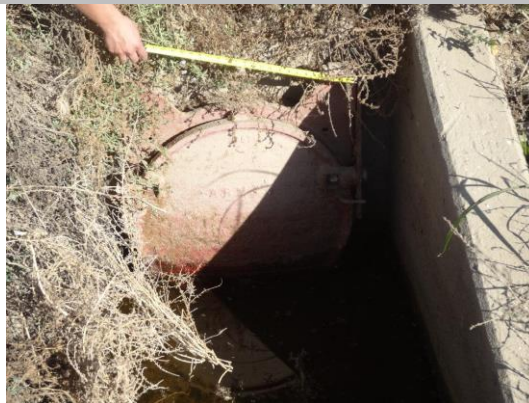
Photo 1 of 3 : UCIP\_SP\_2018\_51821\_43842.jpg

FS\_ID:51821  
DS\_ID:22096  
EP\_NO: N/A  
Repair Type: No Action Needed  
Crossing Status: Found  
UCIP Comments: 05/11/2017 Review of photos indicate less than 1/4 of the inlet is silted in. Since the pipe is in good condition, it has been downgraded from Non-Urgent to No Action Needed. (K. Fazel - UCIP)11/05/2013:- new flap gate on waterside.- cleaning of outlet and inlet pipes required. (P. Amatya - DWR)  
FIELD\_STRUCT\_DESC: 24-inch corrugated metal gravity drainage pipe through the levee, 12 feet below the crown. Flap gate on the waterside (WS) end. Concrete headwall on each end. Installed by USACE in 1961. [Additional Reference(s): DWR Levee Log, 1992. USACE San Joaquin O&M Manual 6, September 1961, (HLM 4.08)].  
FS Date: 11/5/2013

WS view: pipe, flap gate, and concrete headwall on drainage ditch.

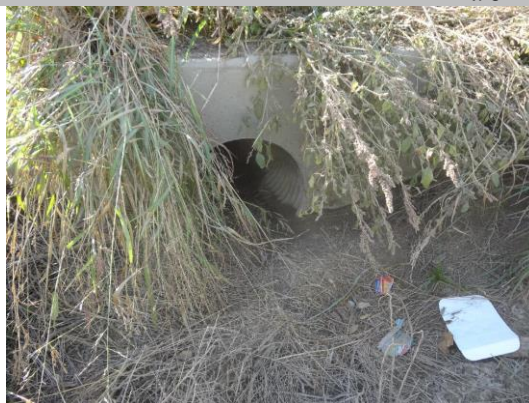
Photo 2 of 3 : UCIP\_SP\_2018\_51821\_43841.jpg

LS view: CM pipe and concrete headwall on levee toe.

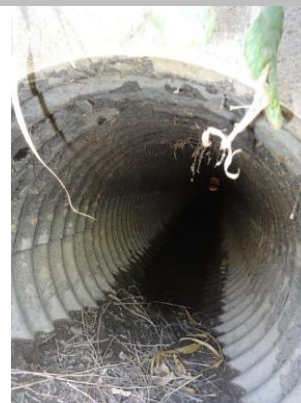
Photo 3 of 3 : UCIP\_SP\_2018\_51821\_43840.jpg

Comment Code						
Inspector Comment						
FS_ID:51821 DS_ID:22096 EP_NO: N/A Repair Type: No Action Needed Crossing Status: Found UCIP Comments: 05/11/2017 Review of photos indicate less than 1/4 of the inlet is silted in. Since the pipe is in good condition, it has been downgraded from Non-Urgent to No Action Needed. (K. Fazel - UCIP)11/05/2013:- new flap gate on waterside.- cleaning of outlet and inlet pipes required. (P. Amatya - DWR) FIELD_STRUCT_DESC: 24-inch corrugated metal gravity drainage pipe through the levee, 12 feet below the crown. Flap gate on the waterside (WS) end. Concrete headwall on each end. Installed by USACE in 1961. [Additional Reference(s): DWR Levee Log, 1992. USACE San Joaquin O&M Manual 6, September 1961, (HLM 4.08)]. FS Date: 11/5/2013

LS view: inside view of the CM pipe on levee toe.

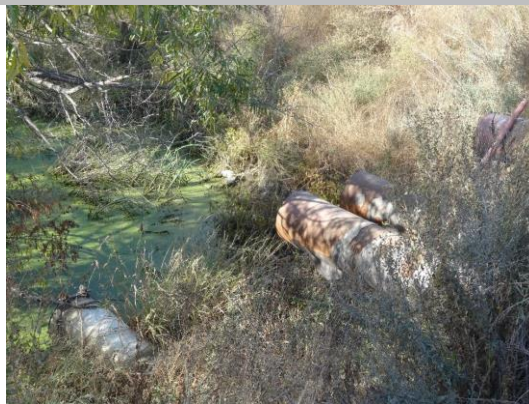
Photo 2 of 3 : UCIP\_SP\_2018\_25026\_45114.jpg

FS\_ID:25026  
DS\_ID:22120  
EP\_NO: 6721  
Repair Type: No Action Needed  
Crossing Status: Found  
UCIP Comments: New intake pipe to pump. Pump house on concrete sump in drainage ditch.  
FIELD\_STRUCT\_DESC: [Vivian Slough Pumping Plant] 2 of 3: 20-inch steel drainage discharge pipe through the levee, 2 feet below the crown. Pumps in a pump house and timber walkway on the landside (LS). Riser on the waterside (WS). (Plans to install a 30-horsepower pump and discharge pipe at existing pumping plant authorized under Permit No. 6721, 1969 - Reclamation District No. 2063. Plans to replace two 20-inch pipes through the levee at existing pumping plant authorized under Permit No. 6721-A, 1980 - Reclamation District No. 2063). [Additional Reference(s): DWR Levee Log, 1992, two 20-inch and one 22-inch pipes referenced. USACE San Joaquin O&M Manual 6, September 1961, (HLM 4.23), two 20-inch pipes referenced].

WS view: discharge pipes end on levee toe. No flap gates on right 3 pipes.

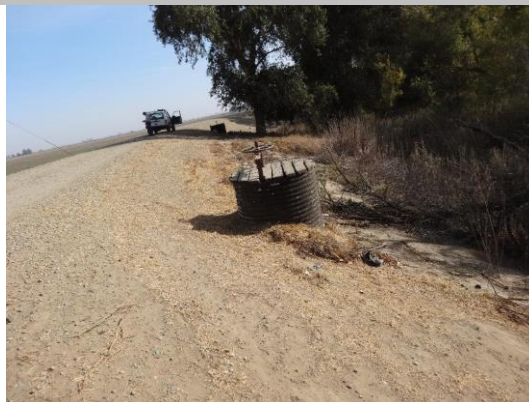
Photo 1 of 3 : UCIP\_SP\_2018\_24632\_43953.jpg

Comment Code					
Inspector Comment					
FS_ID:24632					
DS_ID:22110					
EP_NO: N/A					
Repair Type: No Action Needed					
Crossing Status: Found					
UCIP Comments: No pipe visible on landside.Flap gate not found on the waterside end. Concrete "U" headwalls not found on ends of pipe.					
FIELD_STRUCT_DESC: 36-inch corrugated metal gravity drainage pipe through the levee, 25.5 feet below the crown. Slide gate in a corrugated metal pipe (CMP) riser on the waterside (WS) slope. Flap gate on the WS end. Concrete U-shaped headwall on each end. Installed by USACE in 1961. [Additional Reference(s): DWR Levee Log, 1992. USACE San Joaquin O&M Manual 6, September 1961, (HLM 7.61)].					
FS Date: 11/6/2013

WS view: CMP riser on levee slope. No pipe visible on levee slope.

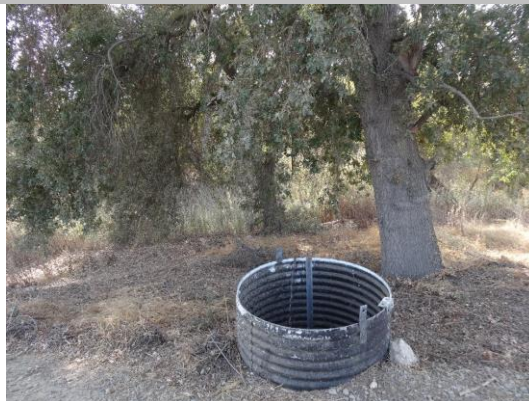
Photo 1 of 3 : UCIP\_SP\_2018\_25031\_45141.jpg

FS\_ID:25031  
DS\_ID:22111  
EP\_NO: N/A  
Repair Type: Non-Urgent  
Crossing Status: Found  
UCIP Comments: Pump mounted on top of concrete pipe sump not found on the waterside. Concrete standpipe not found on the landward side. Looks abandoned.  
FIELD\_STRUCT\_DESC: \*ABANDONED\* 12-inch concrete encased steel drainage discharge pipe through the levee, 7 feet below the crown. Slide gate in a corrugated metal pipe (CMP) riser on the waterside (WS) slope. Pipe open on both ends. Installed by USACE in 1961. [Additional Reference(s): DWR Levee Log, 1992. USACE San Joaquin O&M Manual 6, September 1961, (HLM 7.62), 10-inch pipe referenced].  
FS Date: 11/6/2013

WS view: CMP riser with slide gate. Missing slide gate handwheel.

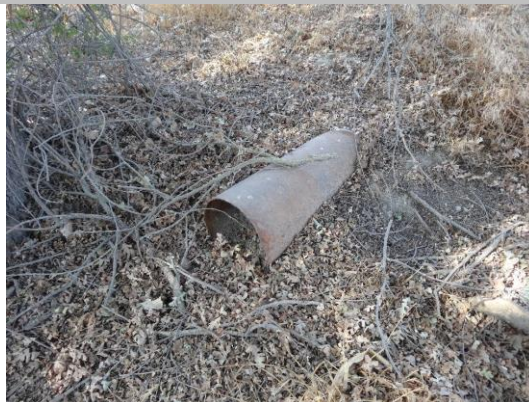
Photo 2 of 3 : UCIP\_SP\_2018\_25031\_45140.jpg

WS view: steel pipe with open-end on waterside slope.

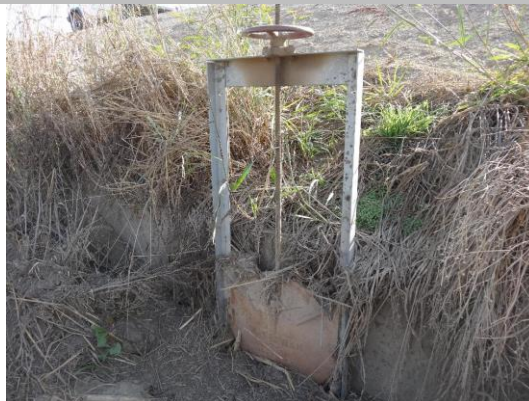
Photo 1 of 2 : UCIP\_SP\_2018\_24638\_43967.jpg

WS view: concrete headwall on levee end. Slide gate on pipe end.

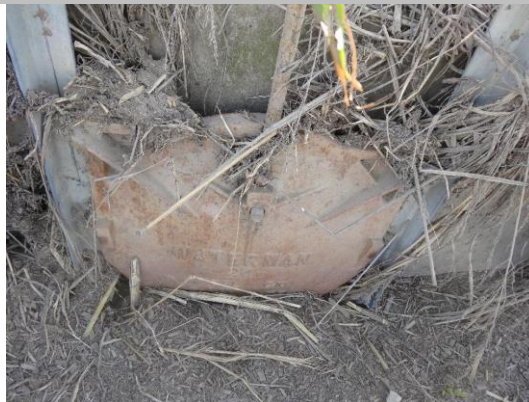
Photo 2 of 2 : UCIP\_SP\_2018\_24638\_43966.jpg

WS view: close view of slide gate on pipe end.

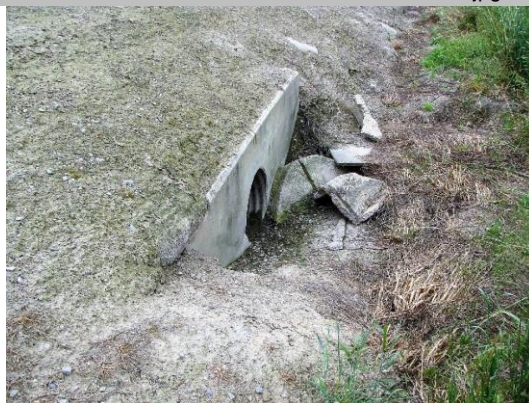
Photo 1 of 3 : UCIP\_SP\_2018\_51825\_77044.jpg

LS inlet as of 4/11/2017 levee inspection. Photo courtesy of DWR inspector Richard Willoughby.

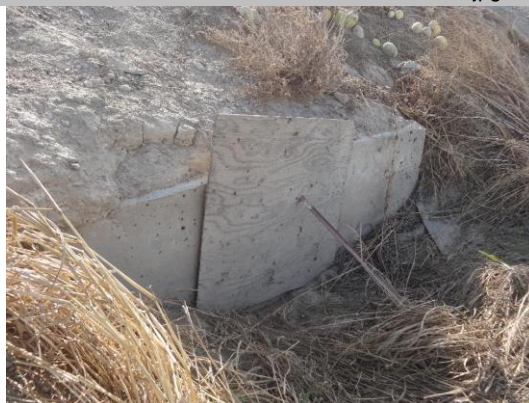
Photo 3 of 3 : UCIP\_SP\_2018\_51825\_43982.jpg

LS view: concrete headwall on levee end. Pipe opening blocked by plywood.

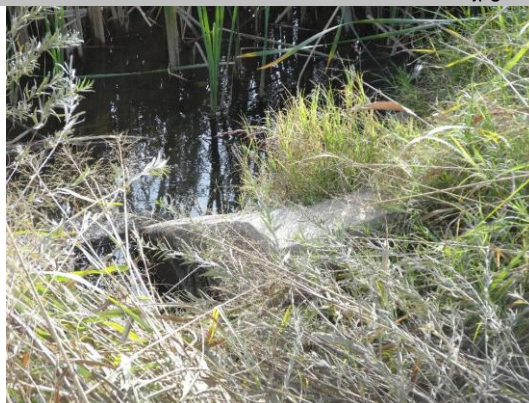
Photo 1 of 2 : UCIP\_SP\_2018\_24645\_43988.jpg

WS view: concrete U type headwall on channel bank. Not accessible.

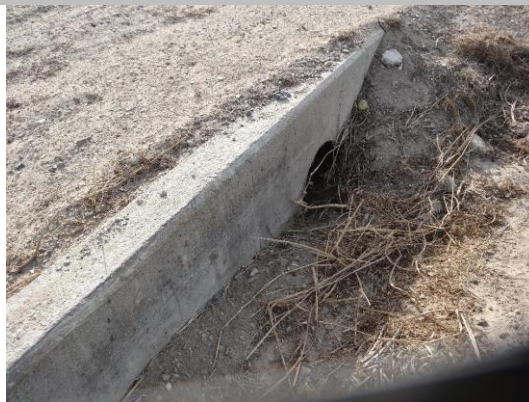
Photo 2 of 2 : UCIP\_SP\_2018\_24645\_43987.jpg

LS view: concrete headwall and partially blocked inlet opening.
